# Guidelines for Improving Energy Efficiency in Historic Buildings

## Historic Preservation Guidelines for Energy Efficiency and Sustainable Practices

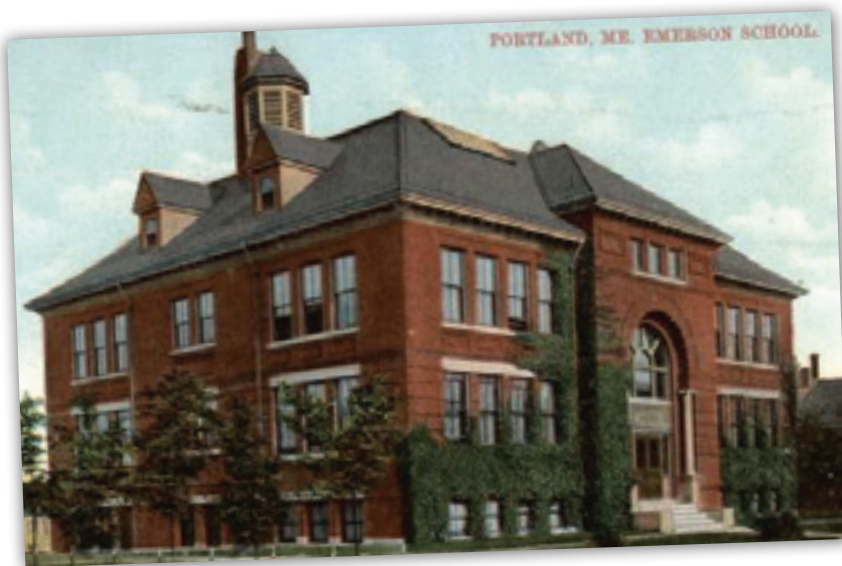
**Figure 3** Large Windows for Ventilation

- Consider how the original ventilation system worked, prior to installation of a heating system.
  - *Recommended:* Research how the original systems functioned. Elements such as tall windows or light wells in schools, commercial buildings and mills were often designed to bounce natural light into the buildings and to ventilate the building. These features are integral parts of the whole design.
    - o *Example:* The Emerson School in Portland, as seen in Figure 3, was built in 1899. The former school has thick masonry walls that store thermal energy and each classroom has a wall of large windows to provide natural light and ventilation. Note, too, the dormers and cupola for ventilation. The circle-head window above the entry and the skylight provide natural lighting.

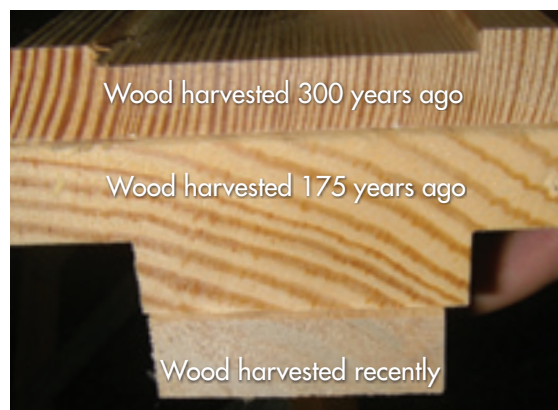
*Old Growth Wood—In the photo above, the top board is in the ballpark of 300 years old with up to 30 growth rings per inch. The second board is 175 years old with 10 growth rings per inch. The bottom board is current lumber sold at a major home improvement supplier with 6 growth rings per inch. (The older wood was salvaged from demolished buildings.)*

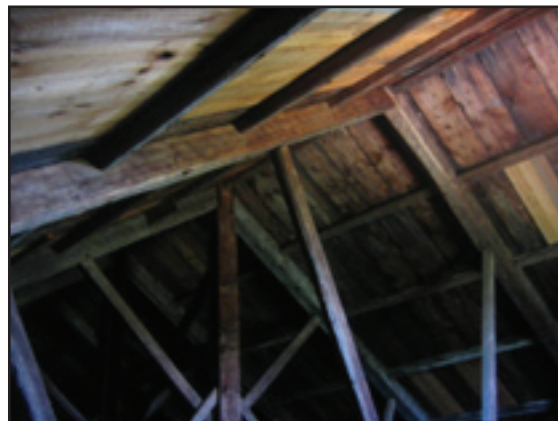
**Figure 4**  
*Old Growth Wood with Patching*

- When new materials are introduced, determine their compatibility with retained historic materials, and the projected life expectancy of these assemblies. Use long-lasting materials that are repairable and that perform effectively with historic materials while allowing measurement of energy-efficiency.
  - *Example:* Many historic structures, such as the Alna Meetinghouse (1789) shown in Figure 4, were constructed from old growth wood. Where the old growth wood roof sheathing was damaged beyond repair, new boards were installed. By avoiding wholesale replacement of historic materials, more long-lasting materials were retained, thus extending future life expectancy of the meetinghouse. Only replace what needs replacing.

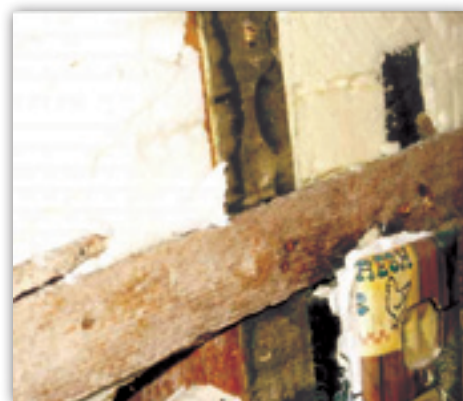
**Figure 5**  
*Urea Formaldehyde Foam Insulation*

- *Example:* Urea Formaldehyde Foam Insulation (UFFI), seen in Figure 5, was an insulation retrofit product used in the

1970's. It was later banned in Canada and the United States after elevated levels of formaldehyde (a known carcinogen) were found in a small number of homes. Not only was it dangerous to have in the walls, but it was also a hazard to remove. Beyond its formaldehyde content, the insulation did not allow for inspection or upgrading of various wall systems, allowing potentially dangerous structural conditions to go unnoticed.

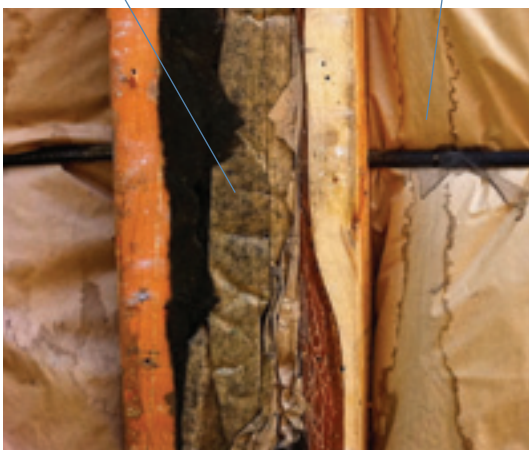
### Open Wall Mold

*Mold or mildew inside wall cavity from cultivated warm, damp environment*

*Water stains from condensed water vapor in wall cavity*

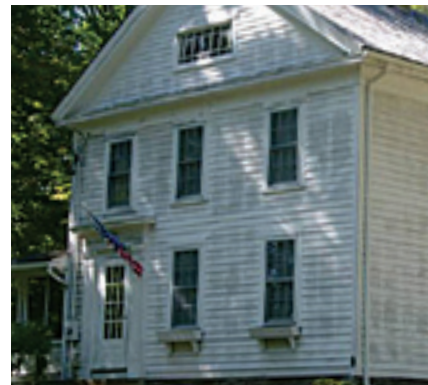
**Figure 5** *Mildew on Exterior*

- o *Example:* Mildew on the exterior of this early 19th century house, seen in Figure 6, appears to be the result of insulation installed in the wall cavities without an adequate internal vapor barrier, as the structural framing (corner braces, studs) is not discolored.
